Manhole Inspection Summary

Manhole # S43CC_039MH

Insp Date: **12/18/07 10:11 AM**

Location Address: **n.bond st**

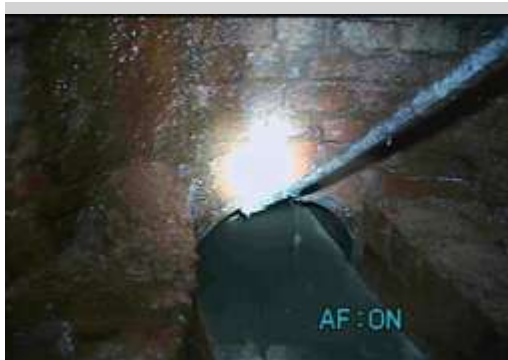
misc

rod stuck in pipe at 12

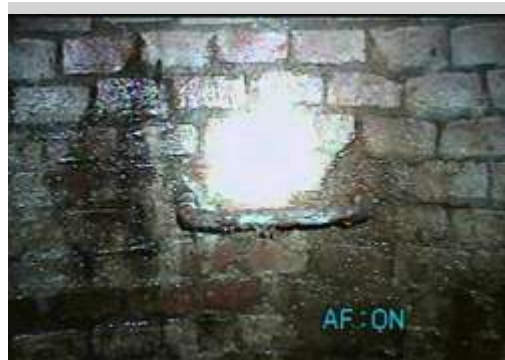
Miscellaneous

Infiltration: ☐ None ☐ Joint ☐ Cracks ☐ Mortar ☐ Roots ☒ **Wall**

more infiltration in barrel

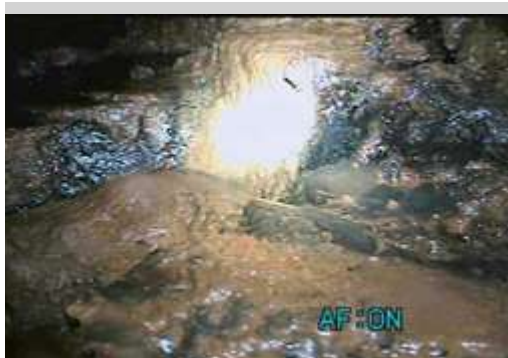
Defect 7

Condition: ☐ Sound ☐ Cracked ☐ Root Intrusion ☒ **Deteriorated** ☐ Leaks ☒ **Debris**

Condition: ☐ Sound ☐ Cracked ☐ Root Intrusion ☐ Deteriorated ☐ Leaks ☒ **Debris**

bench debris, channel debris under pipe at 9

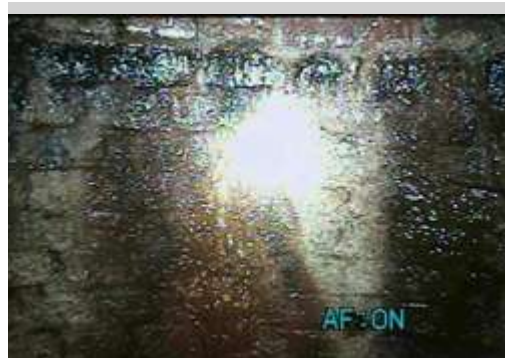
Defect 5

infiltration all around barrel

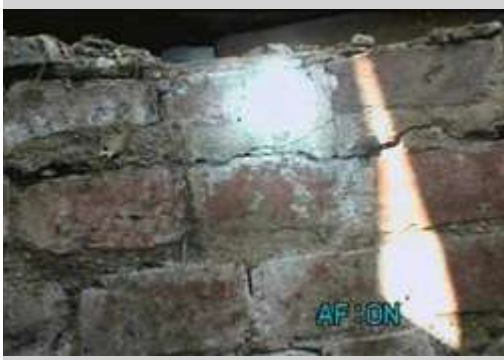
Defect 4

Condition: ☐ Sound ☒ **Cracked** ☐ Root Intrusion ☐ Loose Brick ☐ Deteriorated

crack in corbel

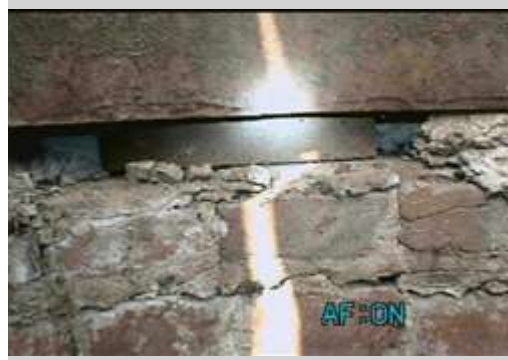
Defect 3

Condition: ☐ Sound ☐ Cracked ☐ Root Intrusion ☒ **Loose Brick** ☐ Deteriorated

loose bricks, frame adj

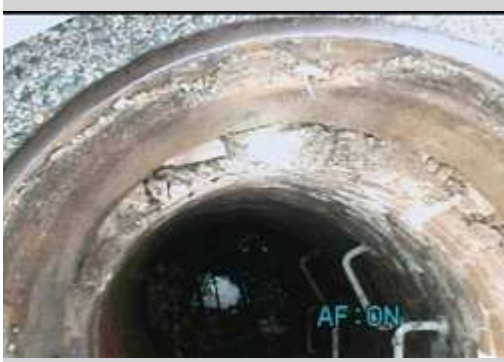
Defect 1

Offset: **2** (in.)

offset

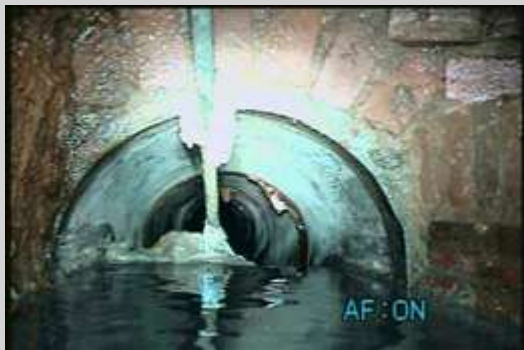
12 O'Clock Outflow

Deposits: ☐ None ☐ Mud ☐ Sludge ☒ **Debris** ☐ Grease

Silt Depth: 0 (in.) Deposits Extent: **Medium**

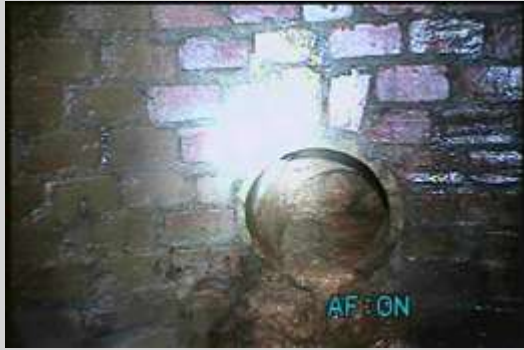
9 O'Clock Inflow

Deposits: ☐ None ☐ Mud ☐ Sludge ☒ **Debris** ☐ Grease

Silt Depth: **0** (in.) Deposits Extent: **Heavy**
